Amendment 39-17125; AD 2012-14-11]

Airworthiness Directives; Various Restricted Category Helicopters

SUMMARY: We are adopting a new airworthiness directive (AD) for Arrow Falcon Exporters, Inc. (AFE), Rotorcraft Development Corporation (RDC), and San Joaquin Helicopters (SJH) Model OH-58A, OH-58A+, and OH-58C helicopters to require inspecting the main rotor mast (mast) for a crack. This AD is prompted by two reported failures of the mast from corrosion-initiated fatigue cracking. The actions specified by this AD are intended to prevent failure of the mast and subsequent loss of control of the helicopter.

2012-14-11 **VARIOUS RESTRICTED CATEGORY HELICOPTERS:** Amendment 39-17125; Docket No. FAA-2012-0739; Directorate Identifier 2012-SW-044-AD.

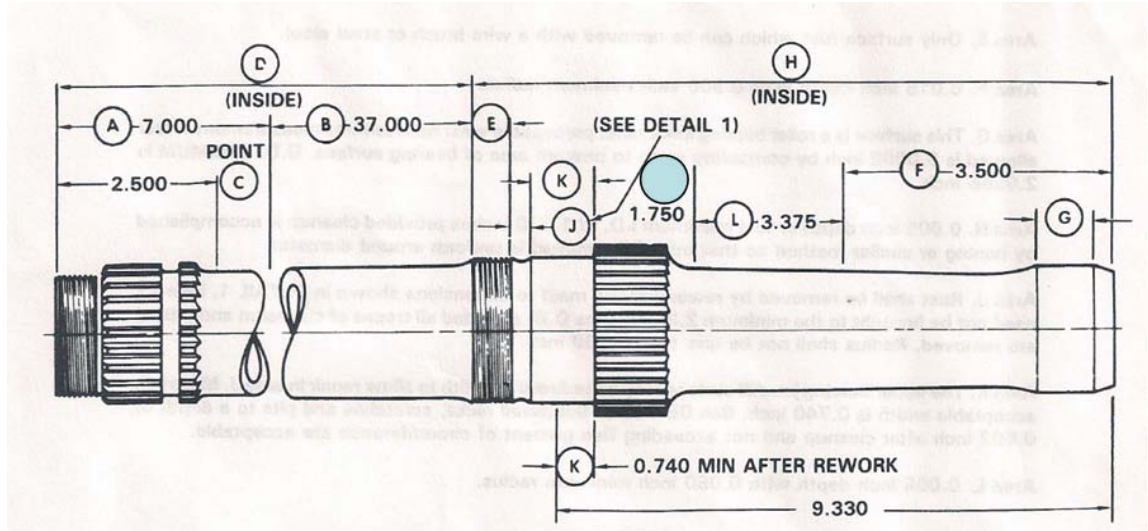
Figure 1 to Paragraph (e)

AFE reported two failures of a mast on an OH-58A+ and an OH-58C helicopter used in agricultural spraying operations. Investigation revealed that the mast failures were caused by fatigue cracking, which initiated from corrosion pitting found in the threaded section of the mast approximately 45 inches from the top of the mast. AFE issued Alert Service Bulletin: 2012-58-01, Revision 1, dated February 20, 2012 (ASB 2012-58-01), which specifies overhauling and inspecting the mast for any cracks, pitting, or corrosion by following the procedures in the latest revision of Aviation Unit and Intermediate

(iii) Using a 10X or higher magnifying glass, inspect the threaded area of the mast as shown in area E of figure 1 to paragraph (e) of this AD for pitting, corrosion, or a crack. Remove any surface rust with a wire brush or steel wool.

(2) If there is a crack, pitting, or corrosion, before further flight, replace the mast with an airworthy mast.
